Another EMC resource
from EMC Standards

EMI Stories 476 to 570

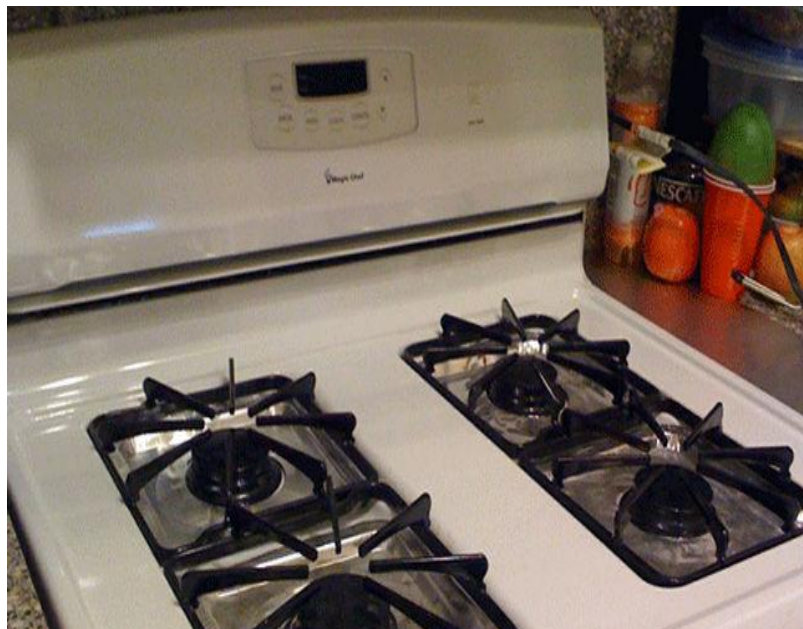
How did this happen? Melnikov and his Brooklyn apartment building's skeptical super eventually figured it out through trial and error: The tenant's ringing cell phone somehow turned on his nearby Maytag oven when it rang. If you're skeptical, check out the video of this in action at the New York Times website and see for yourself.

Calling the situation "highly unusual," Maytag (and other experts) blame the problem on electromagnetic interference -- basically the same thing that happens when your cell phone gets too close to your speakers and it starts making that beep-beep-beeping noise. In this case, the interference didn't make a sound but rather caused the oven to turn on.

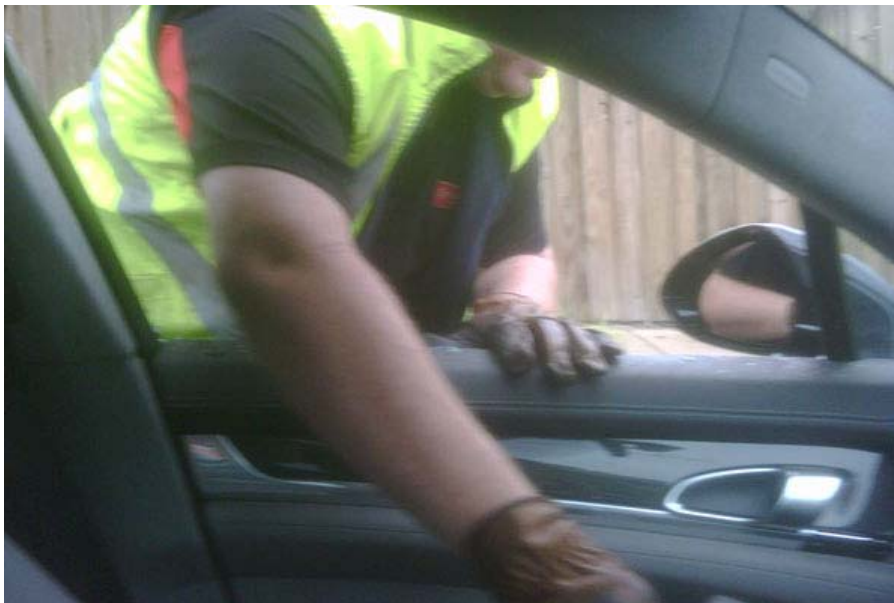
After five minutes of trying to lock and unlock doors (in an effort to reset the system or immobiliser) a phone call was made to Porsche Assistance. It was then that the locks thunked closed — and refused to open. Three people were trapped — wife and child included. Door handles did not work, buttons did not respond and with no ventilation the cabin heated up quickly.

After half an hour — including a phone call to the police — the decision was made to smash a window. (See photograph below, Editor)

Porsche now intends to fit the suppressor units to all Panameras as part of a mandatory service campaign.

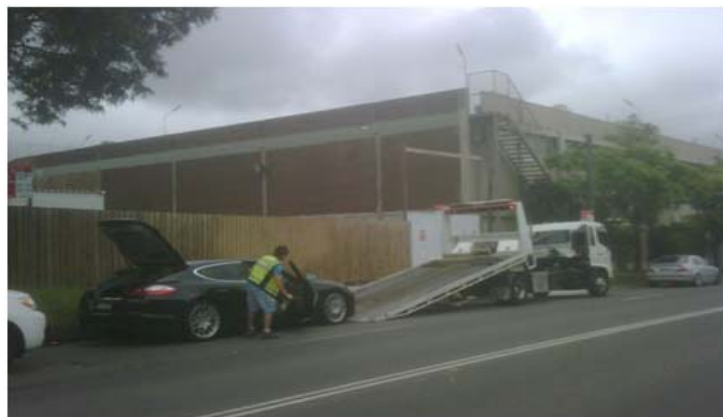
It took another 90 minutes to drag the car on the tow truck, with its electronic handbrake refusing to release. (See photograph below, Editor)

Porsche has since tracked the problem to radio interference, presumably from TV and radio towers in the area. Similar

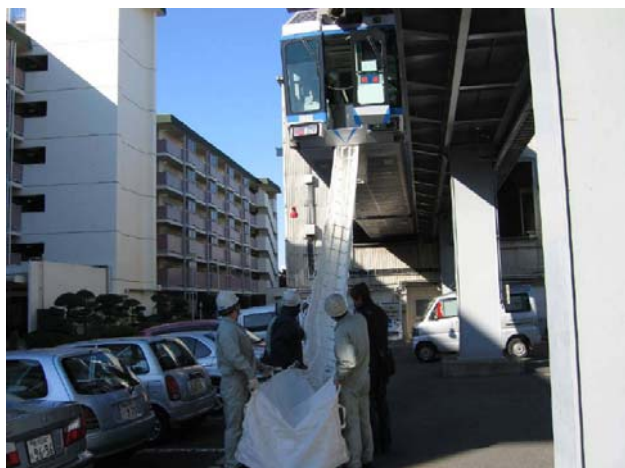
When the train came near to the next station, it could not be decelerated enough even with its emergency brake activated, and caused an overrun. The train finally stopped, fortunately with no casualties, after collision with a rail point.

On 26 June 2009, an accident investigation report, RA2009-6, was issued from the Transportation Safety Board. The Board concluded that the accident was caused by roughly the following reasons:

1. Poorly grounded VVVF inverter (which drives the train) on the train caused excessive noise, which could be coupled to nearby wires;
2. A cable for an unused monitor board was still connected to the CPU, and the cable was not properly protected from possible incoming noise;
3. Noise on the cable could cause interrupt signal to the CPU;
4. The CPU didn't mask (disable) the unexpected interrupt, so the corresponding interrupt handler in the software could be activated due to the noise;
5. Somehow, once activated, the interrupt handler (not expected to be activated in normal situations) disabled all other interrupts after that, which made the acceleration/deceleration process no longer work at all;
6. The integrated watchdog timer couldn't recover the system due to a defect in the control software.

The moral of this story: especially for safety related systems, careful design and verification of the system, including its software, from an EMC point of view, is essential.
