NEW EMI Stories

## New EMI stories – numbers 856 – 890

*Created January 2017 - December 2018. More will be added later.*

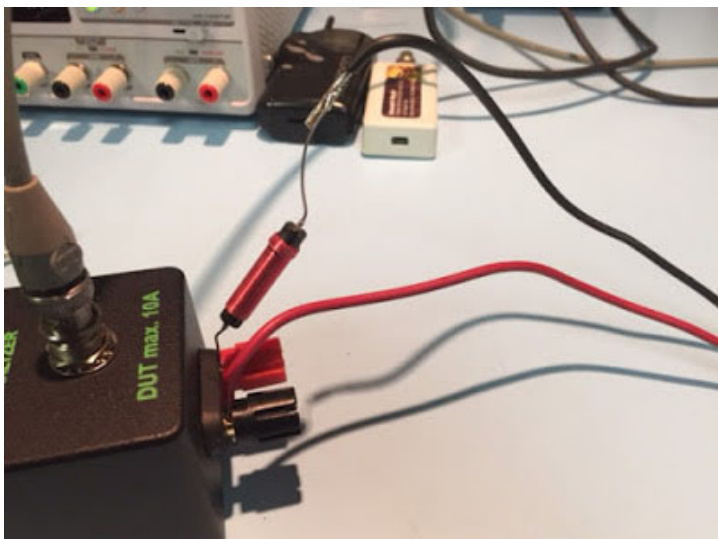
**Figure 3 – A 100  $\mu$ H inductor was all that was required to dramatically reduce the conducted emissions.**

After trying some inductors and common-mode chokes I had on hand, I determined that simply placing a 100 $\mu$ H inductor in series with the input terminal was enough to quiet the emissions rather drastically (Figure 3).

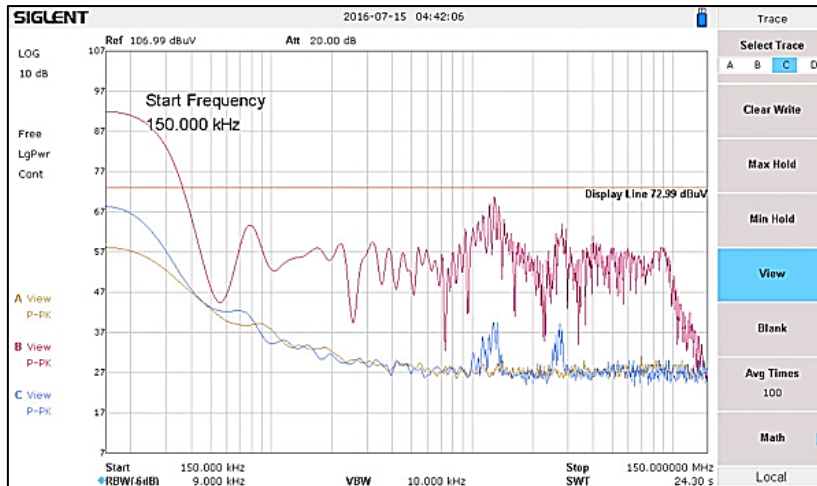
**Figure 4 – The results with the 100 uH inductor installed (blue trace) over 150 kHz to 150 MHz. The red trace is the unfiltered noise and the yellow trace was the ambient baseline noise. The display line is the approximate emissions limit.**

Figure 4 shows the result. The yellow trace was the ambient (baseline) signal level. The red trace was unfiltered (no inductor) and the blue trace was with the inductor added in series with the input voltage to the converter.

The addition of a single inductor nearly reduced the conducted emissions down to the noise floor of the measurement.

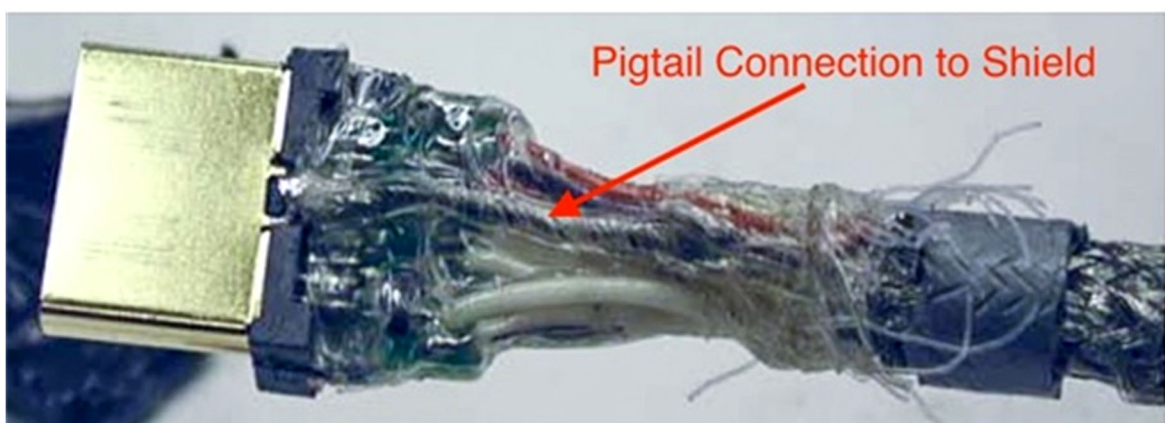
Looking at just the HDMI results, eight cables were tested and two of them had emissions some 20 dB higher than the other six. Dissecting these cables, it quickly became apparent as to the reason – and that was the pigtail issue as noted above. See Figure 1.

Figure 1 – A poorly terminated HDMI cable shield using a long pigtail connection.  
Image, courtesy Dana Bergey and Nathan Altland.

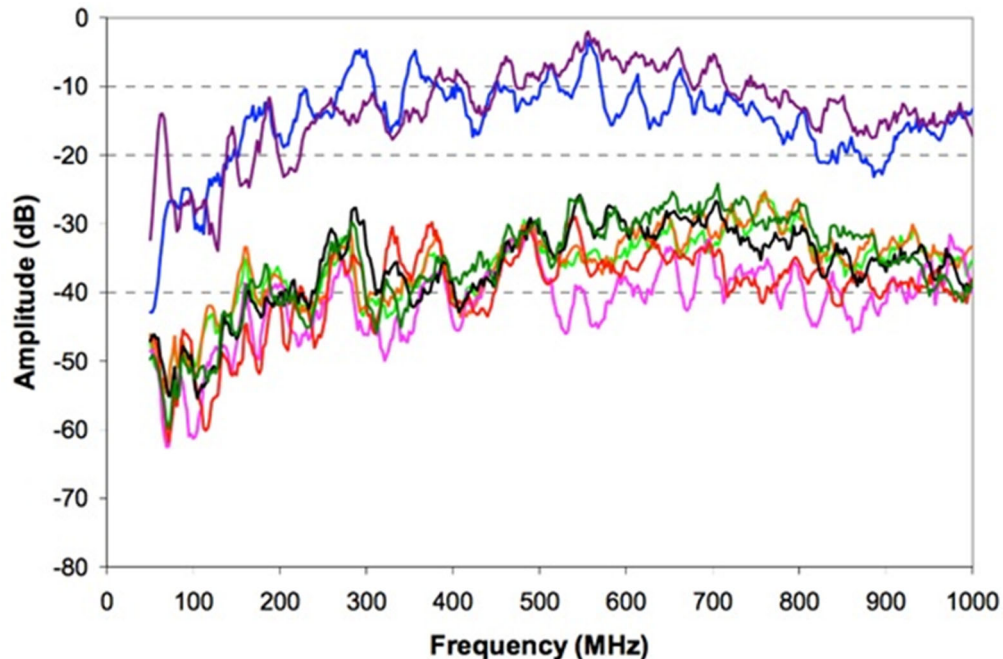
Figure 2 – The resulting radiated emissions from a sample of eight HDMI cables. Two of the samples exhibited EMI 20 dB higher than the average. Image, courtesy Dana Bergey and Nathan Altland.

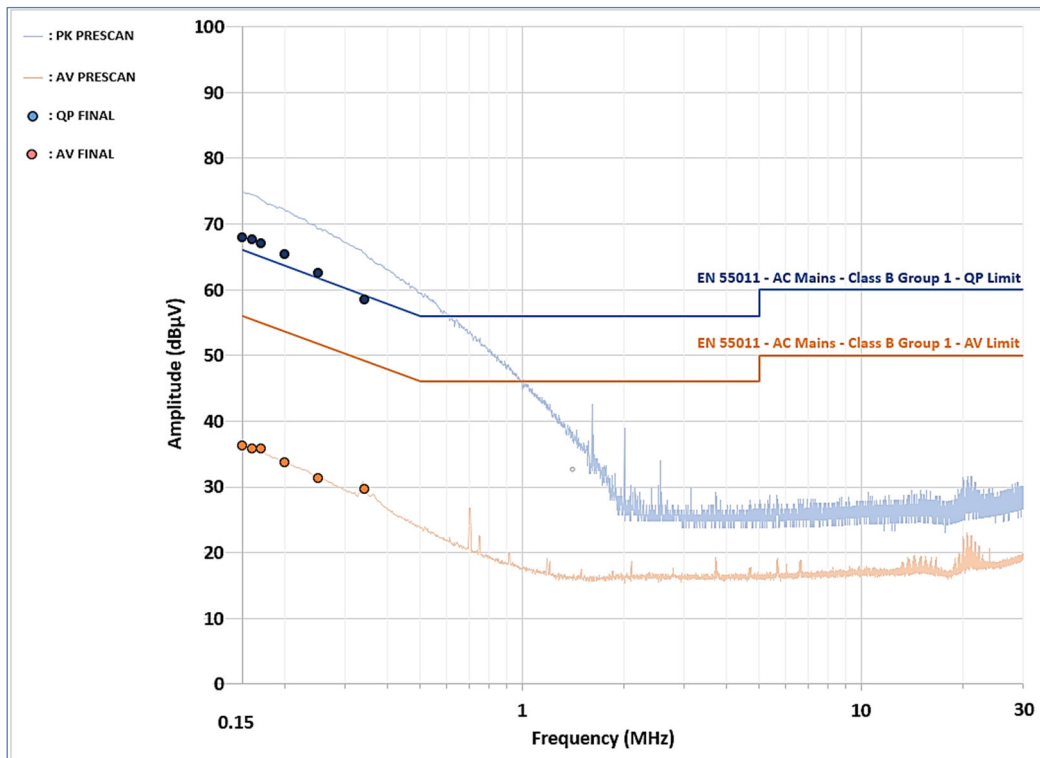
**Figure 2 Conducted emissions plots, blue = QP, brown = AV**

We were then surprised to be presented with this (see Figure 2) for conducted emissions:

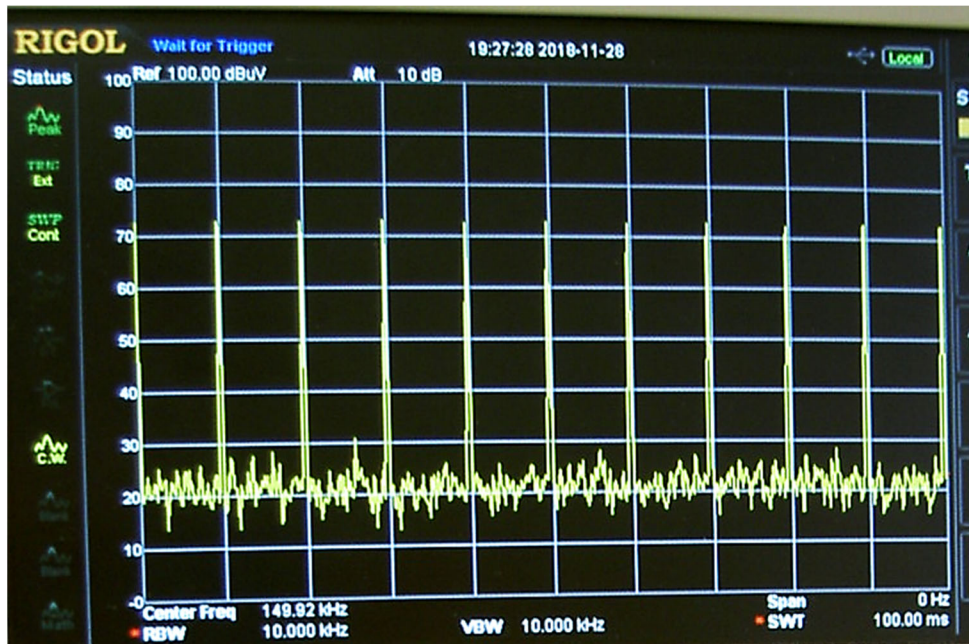
Figure 2

We set up the spectrum analyser in zero span in conjunction with an oscilloscope (with a shared trigger) and confirmed that the emission occurred at zero crossing, see Figure 3.

- i) The deadband in diode conduction caused by their silicon's 0.7V band-gap voltage
- ii) The 'reverse recovery time' of the rectifier's PN-junctions' minority carriers (usually called 'holes'), which even in reasonably fast 1A silicon rectifiers causes them to continue to conduct for several hundred nanoseconds, perhaps even for as long as 1.8 microseconds, *after their voltage has reversed*.
