EMI Stories 856 - 890

## New EMI stories – numbers 856 – 890

Compiled by Keith Armstrong, keith.armstrong@cherryclough.com

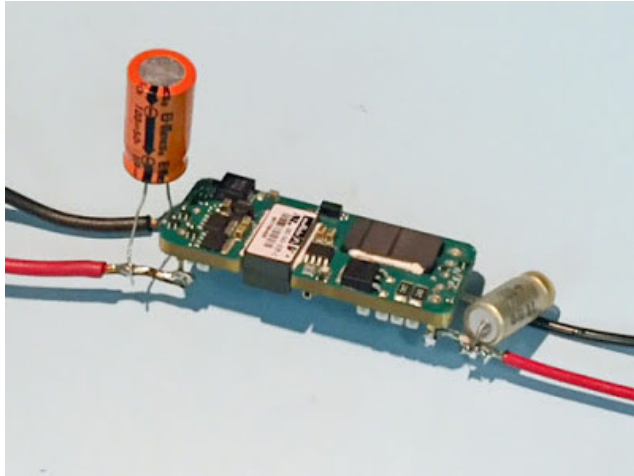
**Figure 1 – The Murata UWE-24/3-Q12 DC-DC converter.**

The manufacturer recommends specific capacitors on the input and output, and I've tack-soldered these on as shown.

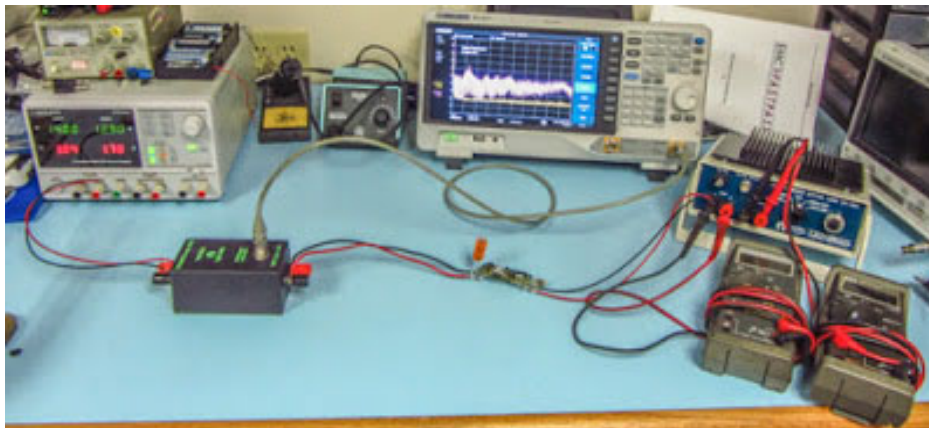
**Figure 2 – The test setup for evaluating the conducted emissions from the Murata DC-DC converter.**

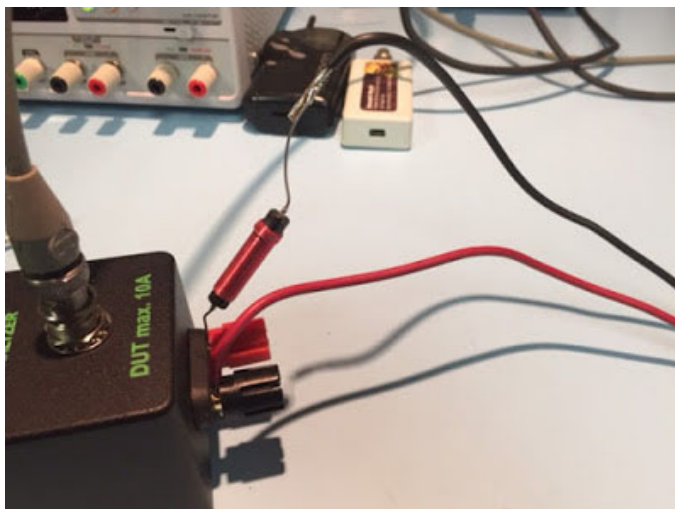
**Figure 3 – A 100  $\mu$ H inductor was all that was required to dramatically reduce the conducted emissions.**

After trying some inductors and common-mode chokes I had on hand, I determined that simply placing a 100 $\mu$ H inductor in series with the input terminal was enough to quiet the emissions rather drastically (Figure 3).

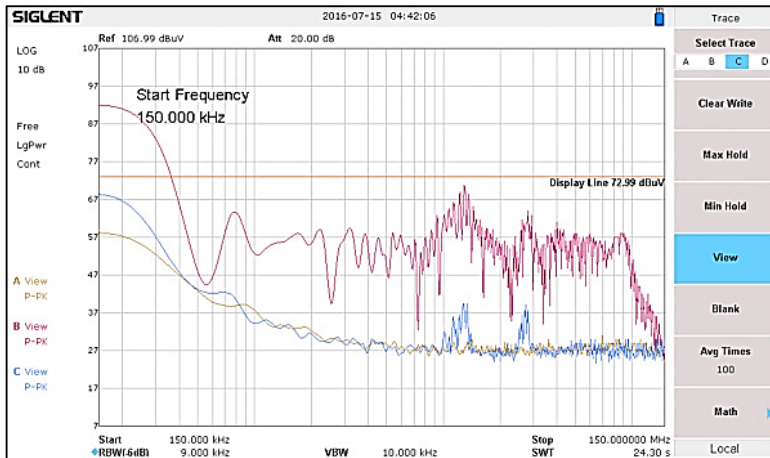
Figure 4 shows the result. The yellow trace was the ambient (baseline) signal level. The red trace was unfiltered (no inductor) and the blue trace was with the inductor added in series with the input voltage to the converter.

The addition of a single inductor nearly reduced the conducted emissions down to the noise floor of the measurement.

**Figure 4 – The results with the 100 uH inductor installed (blue trace) over 150 kHz to 150 MHz. The red trace is the unfiltered noise and the yellow trace was the ambient baseline noise. The display line is the approximate emissions limit.**

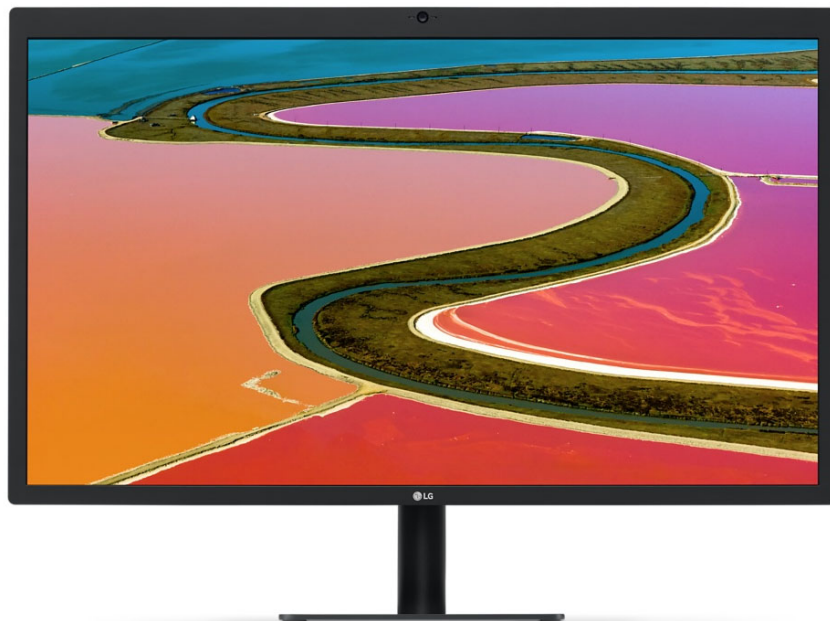
An LG spokesperson confirmed with Ars that the 5K UltraFine monitor isn't adequately shielded from EM radiation, and that displays manufactured after February 2017 "will be fitted with enhanced shielding." Furthermore, existing displays can be retrofitted with extra shielding—if you own the 5K UltraFine, and you're having issues, you should "contact your nearest customer service centre for prompt service." Curiously, the spokesperson said that the Wi-Fi router interference problem only

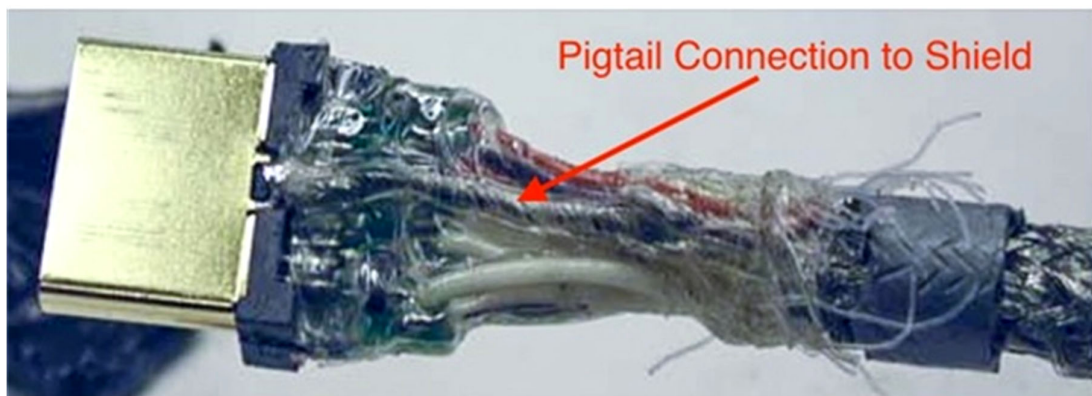
Looking at just the HDMI results, eight cables were tested and two of them had emissions some 20 dB higher than the other six. Dissecting these cables, it quickly became apparent as to the reason – and that was the pigtail issue as noted above. See Figure 1.

Figure 1 – A poorly terminated HDMI cable shield using a long pigtail connection.  
Image, courtesy Dana Bergey and Nathan Altland.

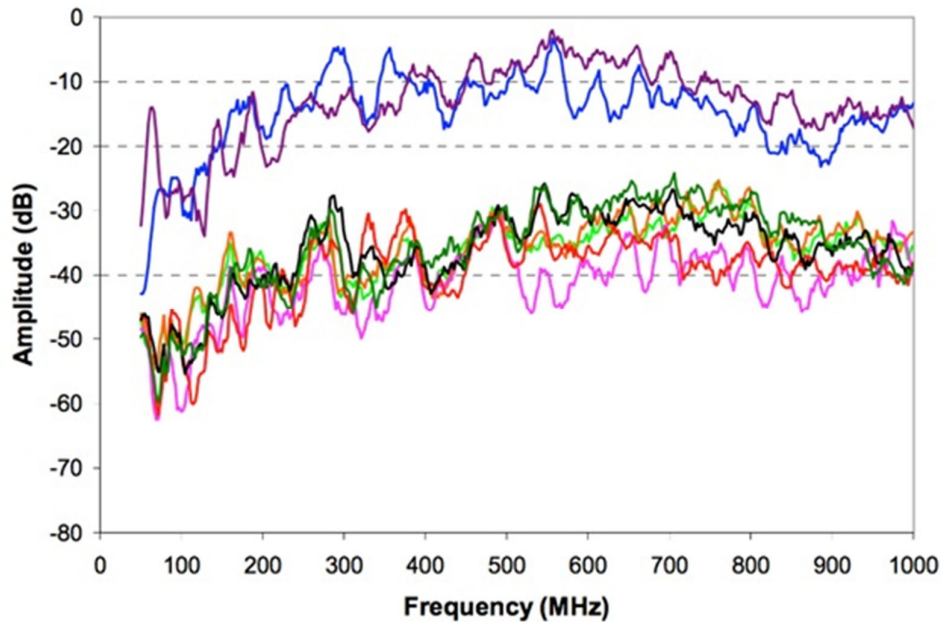
Figure 2 – The resulting radiated emissions from a sample of eight HDMI cables. Two of the samples exhibited EMI 20 dB higher than the average. Image, courtesy Dana Bergey and Nathan Altland.

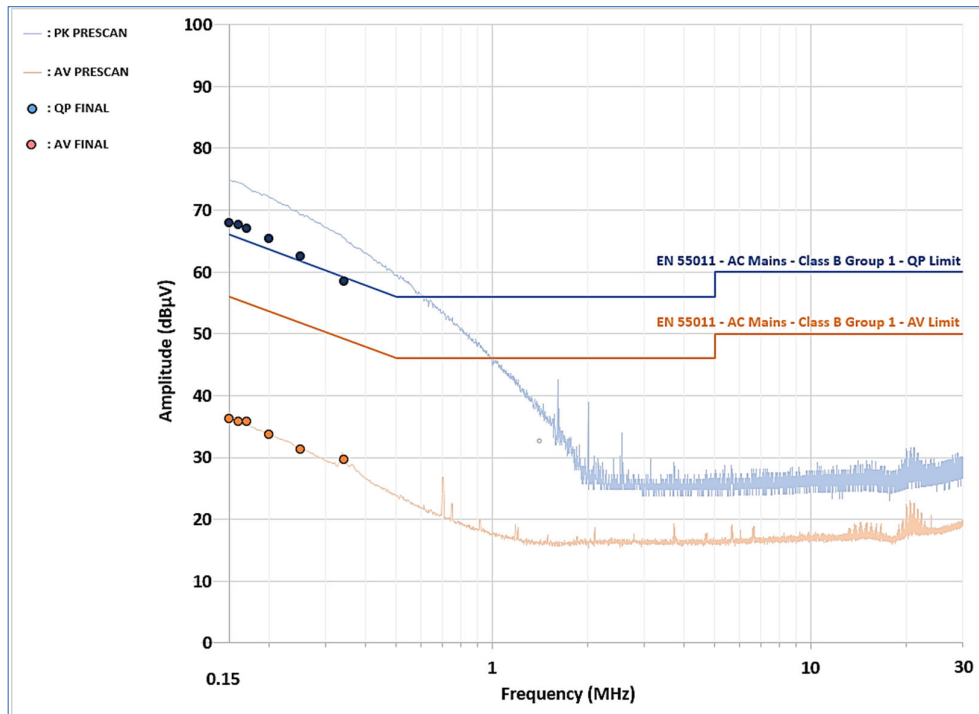
We were then surprised to be presented with this (see Figure 2) for conducted emissions:

**Figure 2 Conducted emissions plots, blue = QP, brown = AV**

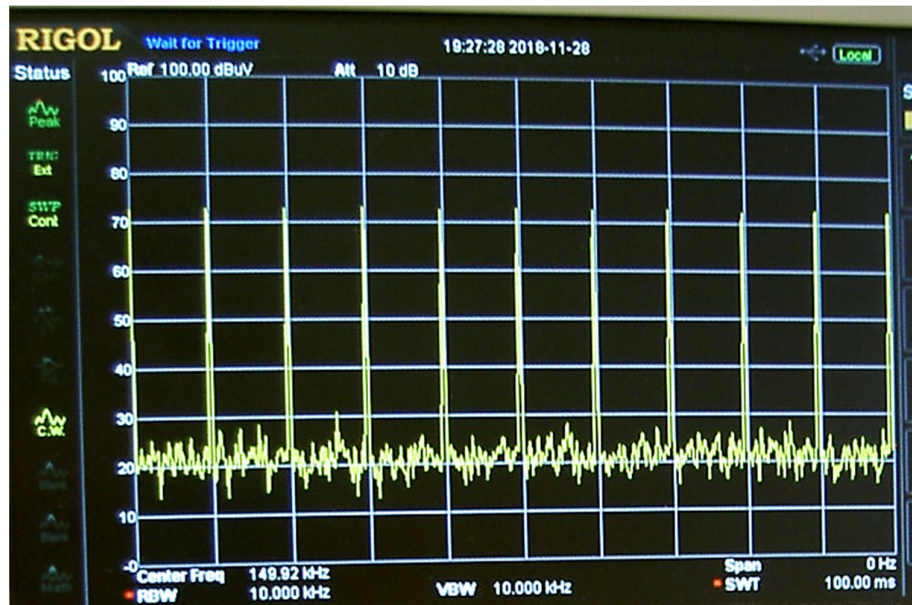
Figure 2

We set up the spectrum analyser in zero span in conjunction with an oscilloscope (with a shared trigger) and confirmed that the emission occurred at zero crossing, see Figure 3.

- i) The deadband in diode conduction caused by their silicon's 0.7V band-gap voltage
- ii) The 'reverse recovery time' of the rectifier's PN-junctions' minority carriers (usually called 'holes'), which even in reasonably fast 1A silicon rectifiers causes them to continue to conduct for several hundred nanoseconds, perhaps even for as long as 1.8 microseconds, *after their voltage has reversed*.
