Another EMC resource
from EMC Standards

EMI Stories 476 to 570

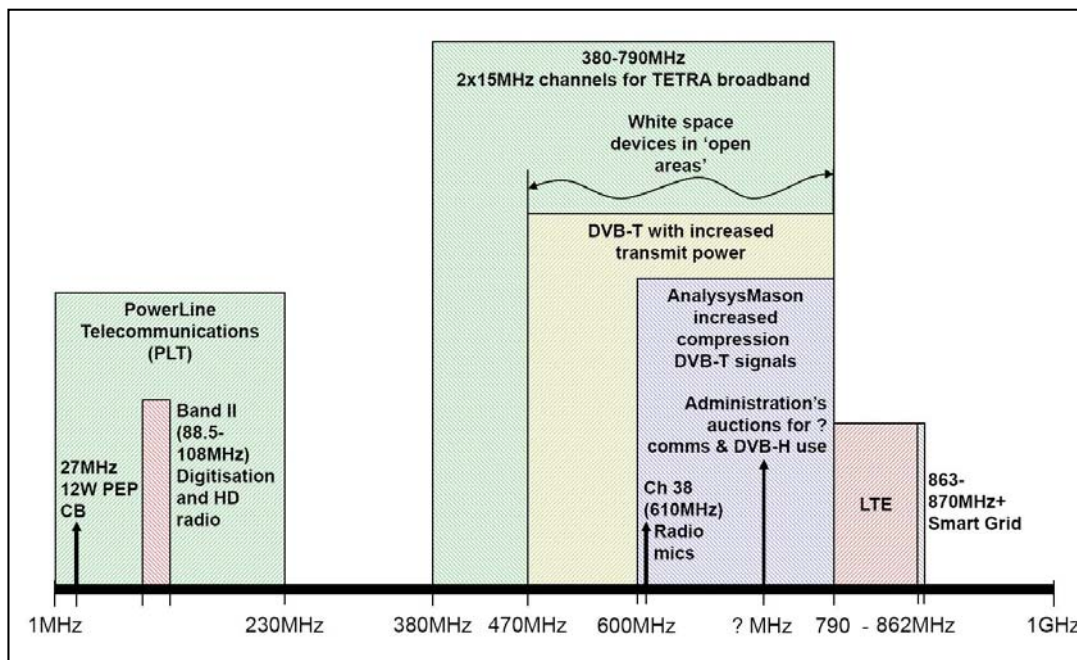
Figure 1: The Digital Dividend Spectrum (from Brian Copsy's TC210 report)

Background: Since the changes in spectrum allocation resulting from the WRC decision of 2007 were announced (*i.e. the "digital dividend, see Figure 1, which contains other surprises too – for example the spectrum allocated to PLT – Editor*), the European Commission (EC) and the Electronic Communications' Committee (ECC) have moved extremely quickly to consider: "The identification of common and minimal (least restrictive) Technical conditions for 790-862 MHz for the digital dividend in the European Union" (CEPT Report 30).
