NEW EMI Stories

## New EMI stories – numbers 856 – 890

*Created January 2017 - December 2018. More will be added later.*

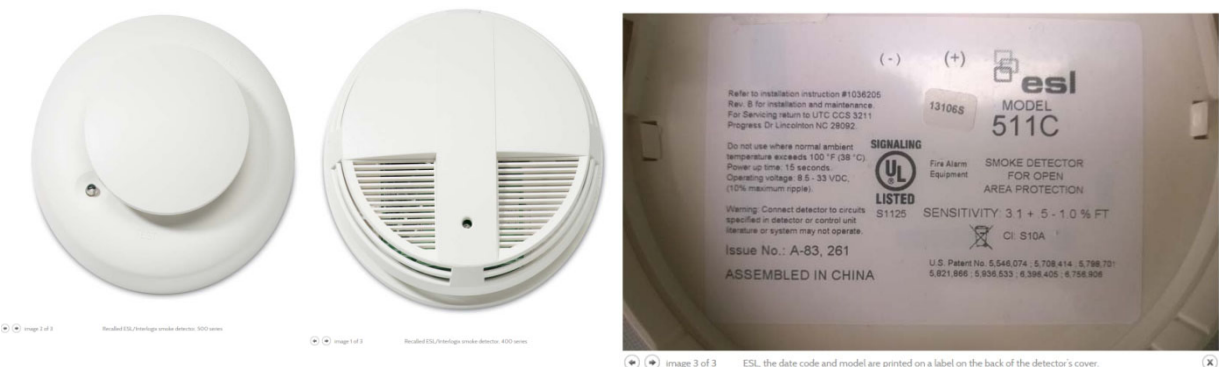
According to a press release issued by the U.S. Consumer Product Safety Commission (CPSC), radio frequency interference (RFI) can cause the smoke detectors to fail to alert consumers of a fire. There have been no reports of incidents or injuries related to the smoke detectors, but the company has issued the product recall to prevent the risk of future incidents.

The recall involves Edwards-branded and Interlogix-branded units that have been hardwired into security systems. They were sold through alarm system, security system and electrical equipment contractors, dealers and installers for use in fire alarm systems installed in commercial buildings, hotels, apartments, schools, dormitories and homes from March 2013 through February 2014.

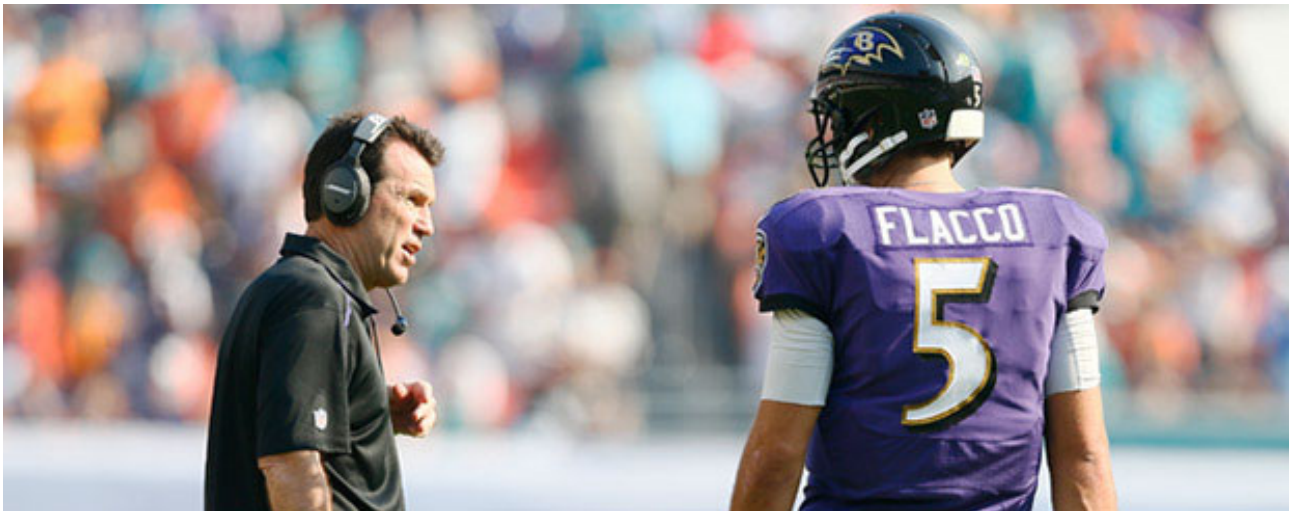
**864) Ravens overcame headset EMI issues in Miami**

The Ravens were unable to communicate to quarterback Joe Flacco's helmet Sunday.

Joe Flacco got in an extra workout running back-and-forth to the sidelines between plays Sunday afternoon. The Ravens quarterback had to consistently jog over to the sidelines to get the play calls from Offensive Coordinator Gary Kubiak because of communication issues from the sideline to the transmitter in his helmet.

All quarterbacks wear a helmet with a radio signal transmitter inside to allow them to hear play calls from the sideline or the coach's box. But that line of communication was halted because of interference with the frequency.

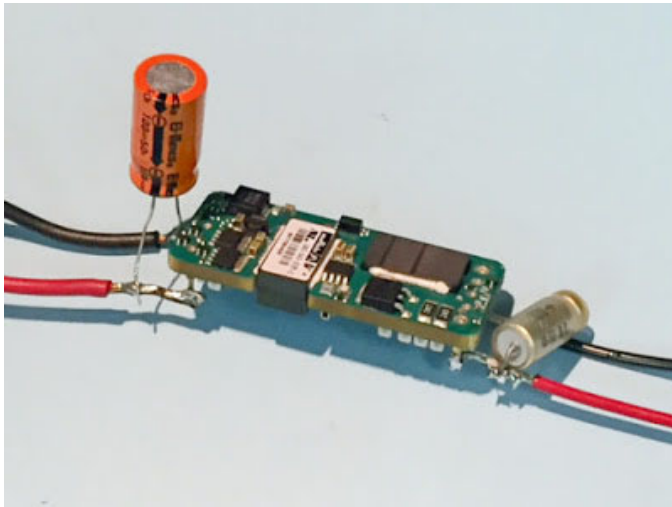
**Figure 1 – The Murata UWE-24/3-Q12 DC-DC converter.**

One example of this type of "drop-in" DC-DC converter is manufactured by Murata and we'll use their model UWE-24/3-Q12, which is an "Eighth Brick" power supply that can take 9 to 36V and convert it to 24V at 3A (Figure 1). My client was using three of these converters on a product and was measuring a high level of radiated emissions, as well as observing broadband noise throughout his system all the way through 150 MHz.

The manufacturer recommends specific capacitors on the input and output, and I've tack-soldered these on as shown.

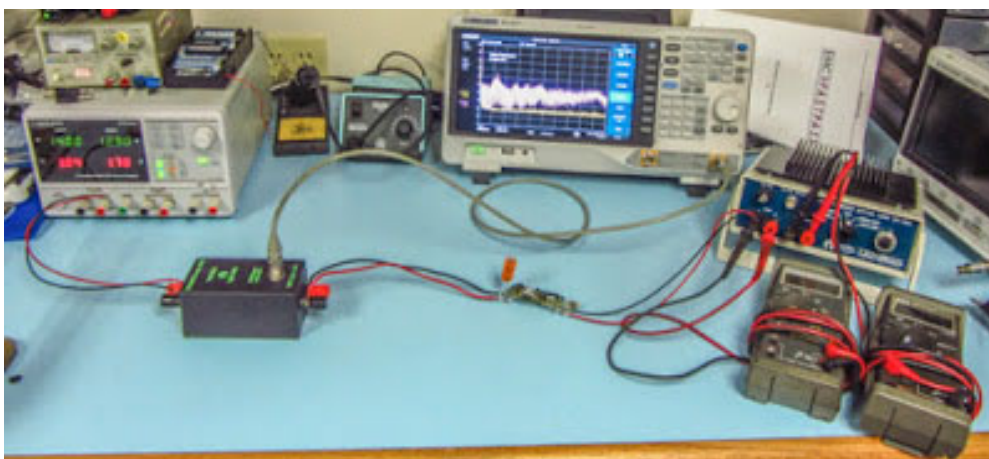
**Figure 2 – The test setup for evaluating the conducted emissions from the Murata DC-DC converter.**

To do this required some instrumentation. I used a Siglent Technologies SPD3303C three output power supply, a Tekbox Technologies TBOH01 5uH LISN, A Tekbox Self-Powered Active Load, and a Siglent Technologies SSA3032X spectrum analyzer. All this gear is available from the U.S. distributor, Saelig Electronics [3]. The active load was really handy, because I could dial in the exact load current I wanted...in this case 0.5 amps, to avoid cooling issues. I connected a couple of Fluke DMMs to

monitor the output voltage and current (Figure 2). The spectrum analyzer picked off the conducted emissions via the LISN.

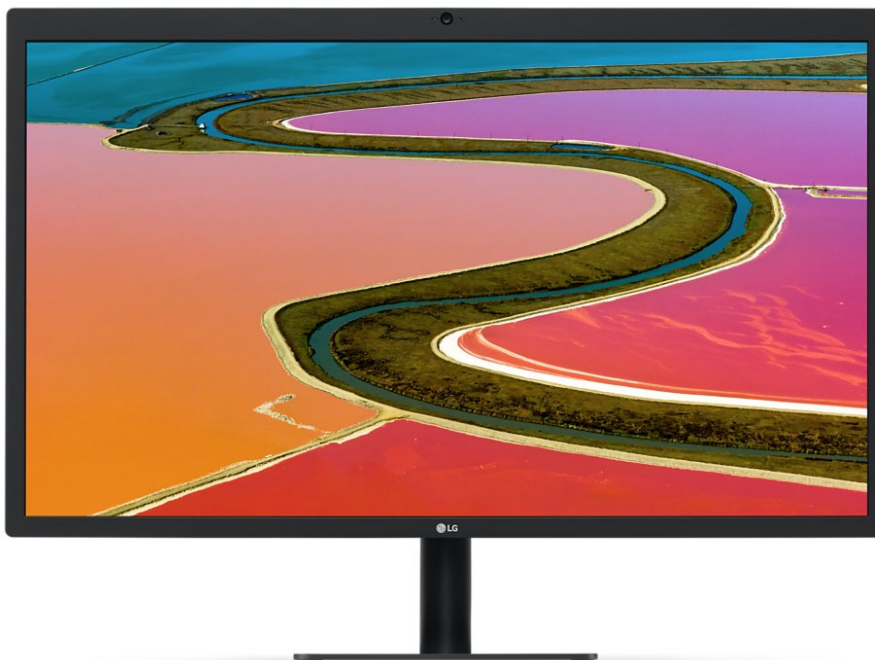
In recent days, I've encountered a similar situation, albeit somewhat in reverse. Apple's been whittling down its product plethora lately, not only turning its back on its longstanding networking equipment presence but also dropping its line of branded displays. Back in June of last year, the company discontinued its last LCD, a Thunderbolt-interface model; a couple of months later, Apple formalized a reference-sell relationship with LG Electronics. Only one problem, though; LG's 27" "UltraFine 5K" display ([www.apple.com/shop/product/HKN62LL/A/lg-ultrafine-5k-display](http://www.apple.com/shop/product/HKN62LL/A/lg-ultrafine-5k-display)) tends to misbehave when in close proximity to a router. According to 9to5Mac's testing, the LCD begins to flicker when a router is approximately 2 meters (6.5 feet) away; any closer than that and the display will eventually go completely dark. The destructive interaction between router and display can in some cases be so severe as to lock up a connected computer, necessitating a restart even if the router is moved away again.

LG's Ultrafine 5K display, from [www.apple.com/shop/product/HKN62LL/A/lg-ultrafine-5k-display](http://www.apple.com/shop/product/HKN62LL/A/lg-ultrafine-5k-display)  
*(Taken from <http://www.edn.com/electronics-blogs/brians-brain/4458576/Electronics-interference--LG-displays-and-routers>, by Brian Dipert on June 26, 2017 in the "EDN Network" [www.edn.com](http://www.edn.com). Kindly sent in by Ronny Deseine of Barco NV, Belgium, on 10 July 2017. Also see: <https://tech.slashdot.org/story/17/01/30/2241256/lgs-ultrafine-5k-display-becomes-useless-when-its-within-two-meters-of-a-router>, and <https://9to5mac.com/2017/01/30/lg-ultrafine-5k-display-router-disconnecting/>)*

An LG spokesperson confirmed with Ars that the 5K UltraFine monitor isn't adequately shielded from EM radiation, and that displays manufactured after February 2017 "will be fitted with enhanced shielding." Furthermore, existing displays can be retrofitted with extra shielding—if you own the 5K UltraFine, and you're having issues, you should "contact your nearest customer service centre for prompt service." Curiously, the spokesperson said that the Wi-Fi router interference problem only
