EMI Stories 856 - 890

## New EMI stories – numbers 856 – 890

Compiled by Keith Armstrong, keith.armstrong@cherryclough.com

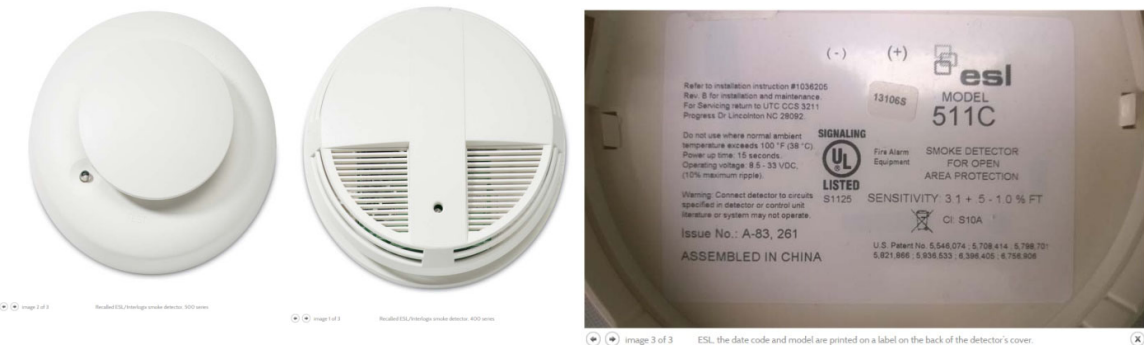
According to a press release issued by the U.S. Consumer Product Safety Commission (CPSC), radio frequency interference (RFI) can cause the smoke detectors to fail to alert consumers of a fire. There have been no reports of incidents or injuries related to the smoke detectors, but the company has issued the product recall to prevent the risk of future incidents.

The recall involves Edwards-branded and Interlogix-branded units that have been hardwired into security systems. They were sold through alarm system, security system and electrical equipment contractors, dealers and installers for use in fire alarm systems installed in commercial buildings, hotels, apartments, schools, dormitories and homes from March 2013 through February 2014.

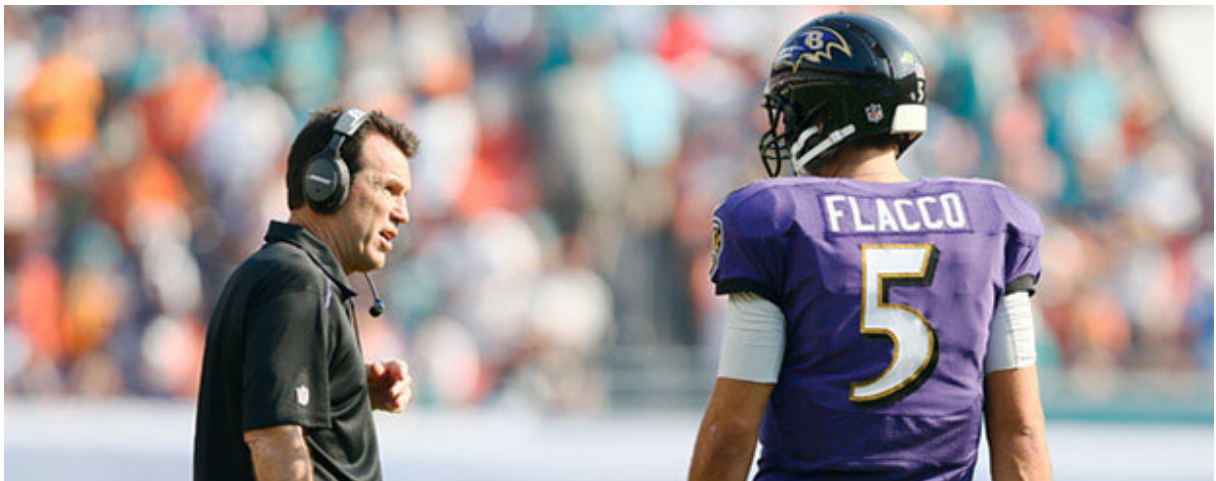
The Ravens were unable to communicate to quarterback Joe Flacco's helmet Sunday.

Joe Flacco got in an extra workout running back-and-forth to the sidelines between plays Sunday afternoon. The Ravens quarterback had to consistently jog over to the sidelines to get the play calls from Offensive Coordinator Gary Kubiak because of communication issues from the sideline to the transmitter in his helmet.

All quarterbacks wear a helmet with a radio signal transmitter inside to allow them to hear play calls from the sideline or the coach's box. But that line of communication was halted because of interference with the frequency.
