Another EMC resource
from EMC Standards

EMI Stories 286 to 380

Helping you solve your EMC problems

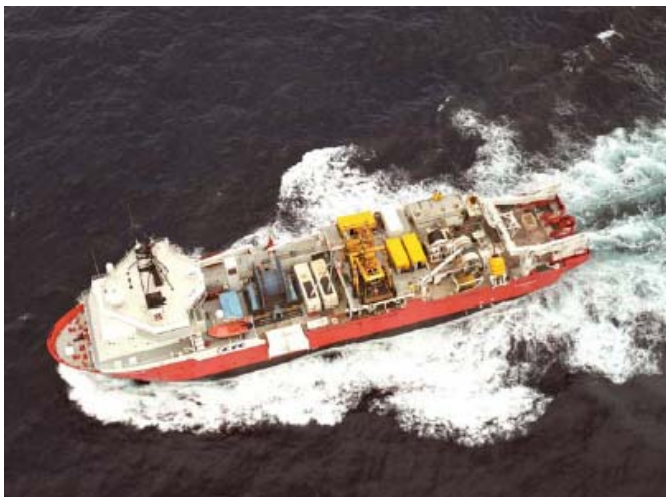
354) Marine mains supply harmonic distortion problems solved

The Ocean Challenger is a very high bollard pull cableship of UT746C dual role design, equipped with a Rockplough that allows for simultaneous cable lay and burial to 1.0m depth in fractured rock, 2.2m in sand/clays and 3.0m in soft soils. The Ocean Challenger's trenching operation is performed by a 2MW Remotely Operated Pipe-line Trenching Vehicle, referred to as the ROV PT1, which is capable of operating in depths of up to 2000m. The PT1 is fitted with ten 30kW electric thrusters for manoeuvring and four 300kW Jet Sword high volume flow rate electric pumps.

The electric thrusters and pumps are independently speed controlled via AC PWM VFD's (Variable Speed Drives) mounted in the surface module. These 400V AC drives are equipped with sinus output filters and 400V to 3300V step-up transformers. From the surface module the 3300V is fed down an umbilical cable to the 3300V thrusters and pump motors. The step up in voltage is required due to the voltage drops associated with very long cable runs extending as much as 2000m.
