EMI Stories 381 to 475

## EMI Stories 381 to 475

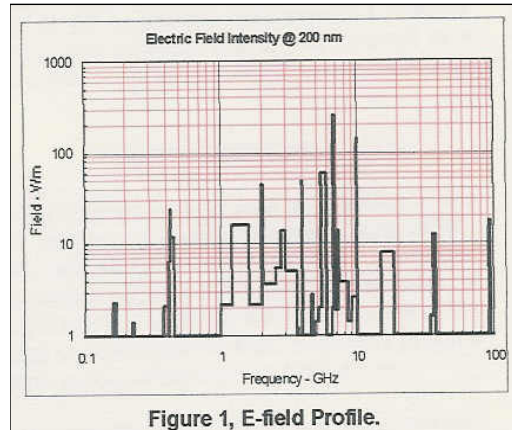
MIL-STD-461E (table 1B) requires a space system to be compatible with high external EME levels of 100V/m from 100MHz-1GHz, but Figure 1 indicates that external fields at 200 nautical miles (nm) height due to earth-based sources such as radio, TV and radars occur out to 100GHz, and up to 250V/m. The field strength at 100 nm will be twice as high.
