Another EMC resource
from EMC Standards

EMI Stories 666 to 760

Helping you solve your EMC problems

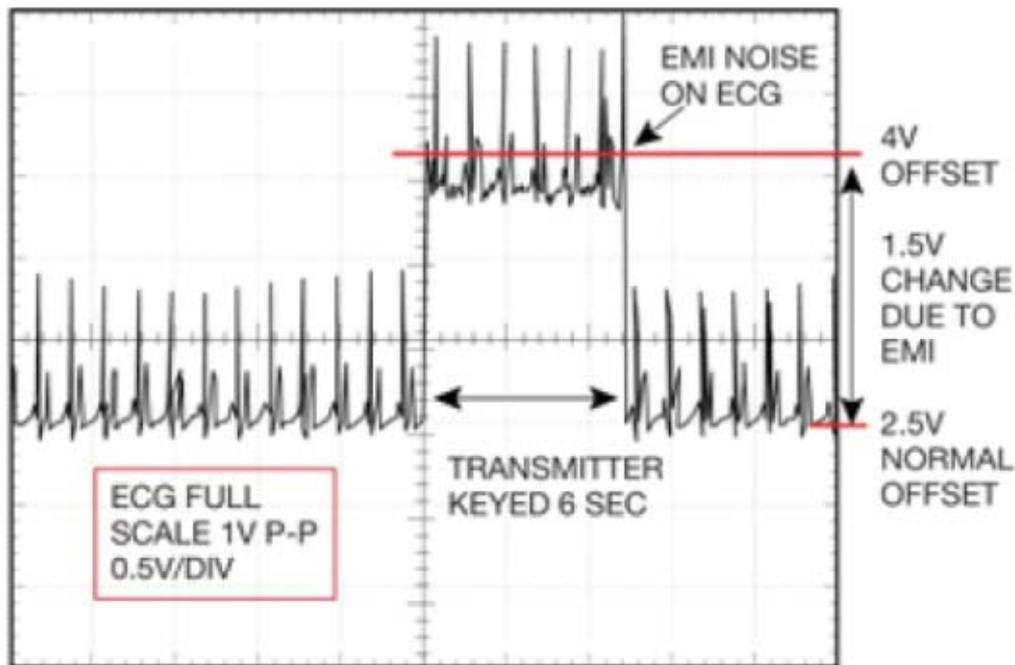
Figure 1 EMI from a cell phone can cause a 1.5V change from normal on an ECG. The ECG diagnostic tool senses a heart while a 0.5W, 470MHz transmitter turns on and off just one and a half feet away.

The heart's input signal to the system is approximately 0.25 mV p-p. This small signal requires an instrumentation amplifier's gain of approximately 6000V/V. The good news is that the results in Figure 1 do not represent the performance of a doctor's office ECG-measurement tool. This measurement was actually taken in an engineer's lab from the board in Figure 2.

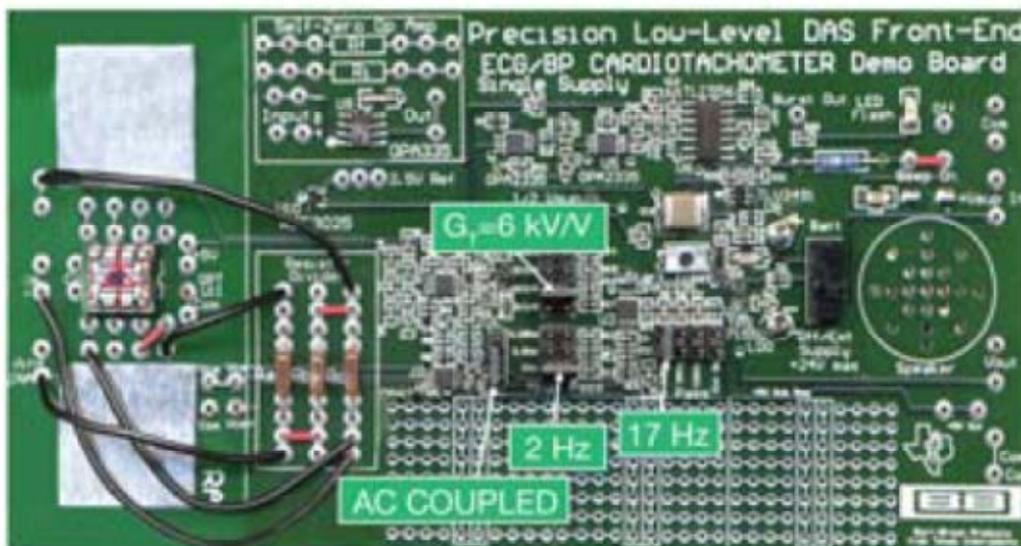
Figure 2 An engineer's precision, low-level ECG cardiometer board took the measurements for Figure 1.

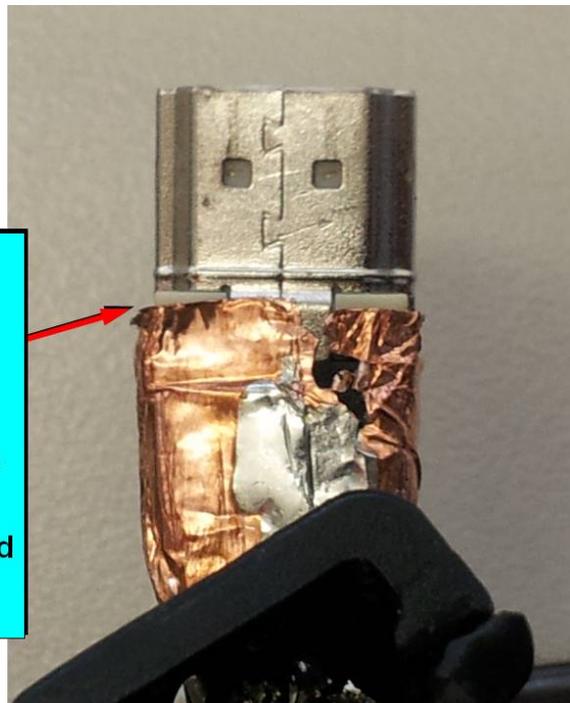
Cutting away the overmoulded plastic revealed copper tape wrapped around the cable's braid, and the plug's shielded shell, but only soldered to the shell at one point

When soldered all around the body of the shell, emissions fell by 20dB

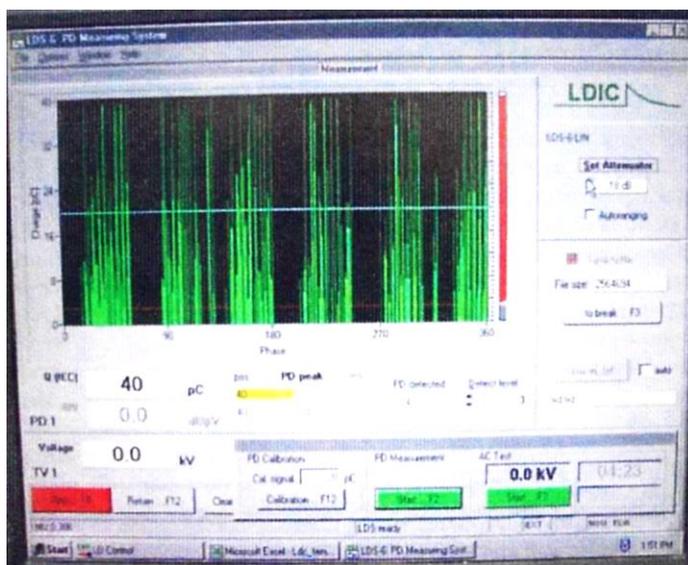
Upon startup of this new production line, use of the partial discharge test setup revealed a problem. As shown in Figure 1, the partial discharge test system revealed a leakage much larger than five picocoulombs. In fact, the test yielded a leakage of almost 40 picocoulombs, eight times the acceptable level. Plant engineers were concerned that the partial discharge test system was not working properly and decided that this system could not be used until someone determined the reason for the unacceptable test results.

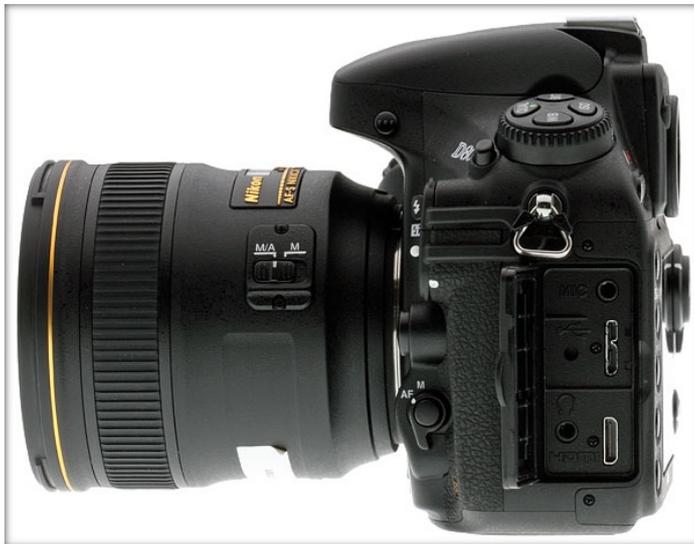
Nikon's D800 is the first DSLR with USB 3.0 connectivity, but Eye-Fi has discovered that it can interfere with the default channel used by its Wi-Fi connected flash cards.

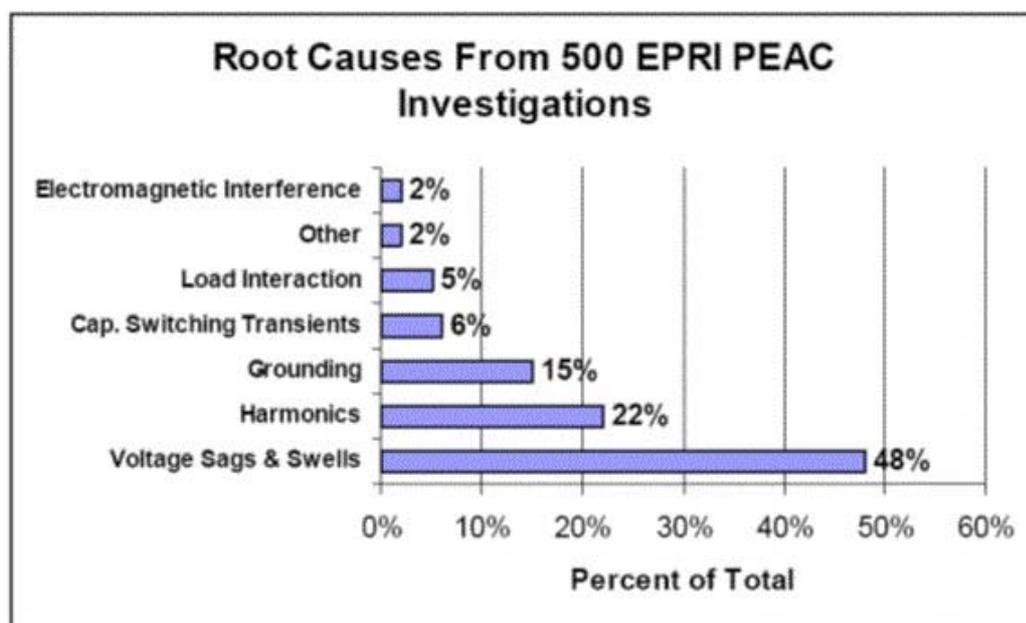
Figure 5.1 Breakdown of the power quality phenomena found in more than 500 EPRI investigations
